ASBESTOS SURVEY REPORT

City of Houston Bridge across Hoods Bayou on Greens Road GREENS ROAD ALDINE WESTFIELD to JOHN F. KENNEDY HOUSTON, TX

WBS No: N-000686-0002-3 Task Number 14-05 ECMS Project Number: 3800

Re:Comprehensive Asbestos Survey

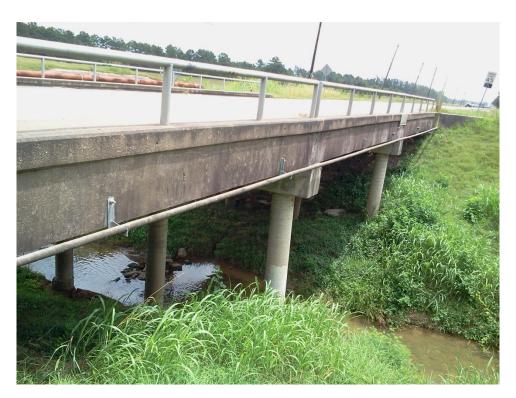
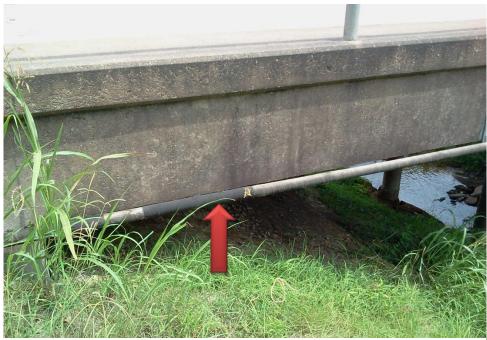
Samples A1 – A3 pipe coating insulation all negative ACM

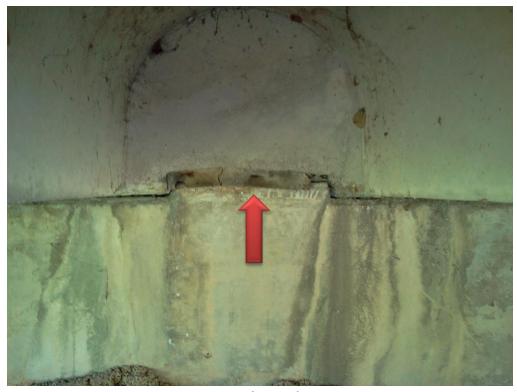
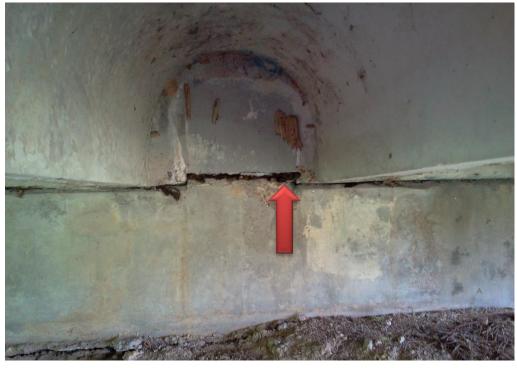
Expansion Joints

The quantity of the material to be removed to allow for demolition activities is approximately 60 sq. ft. The material is in fair condition, with only minor damage to edges that are exposed. The damaged areas should be encapsulated to avoid additional damage prior to demolition.

Ten (10) bulk material samples were taken of suspect asbestos containing materials. A total of four (4) samples were collected from the **expansion joint material** – One (1) of the 4 samples **revealed positive acm @ 7% Chrysotile asbestos;** dark brown/black color and in fair condition.

Samples A4 - A7 expansion joint material underneath base of bridge - positive ACM

Abatement approximately 60 sq. ft. of asbestos containing mastic material at bridge base by standard wet methods and proper disposal of materials. Estimated Cost: \$3,000.00

If contractors carefully remove asbestos-cement materials using tools that do not cause significant damage as defined by NESHAP, the materials are not considered RACM and can be disposed of with other construction debris. Asbestos associated with cement products are subject to the asbestos NESHAP guidelines and should be determined by the owner or operator on a case-by case basis based on the demolition techniques to be used.

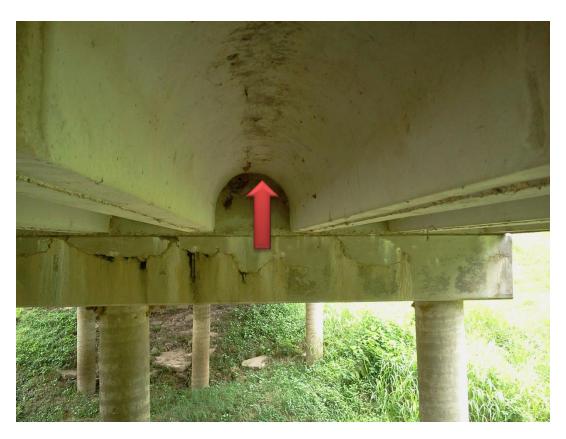
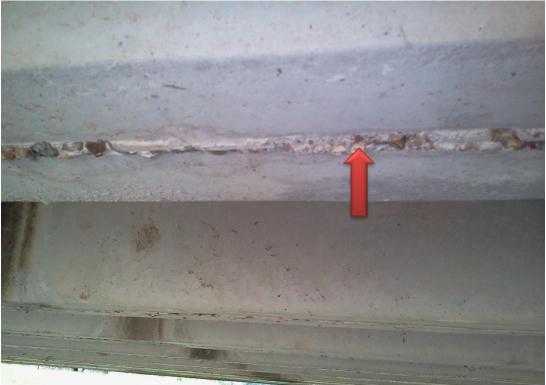
Samples A8 – A10 cementitious coating underneath bridge - negative ACM $\,$
